AN INVESTIGATION OF THE FORMATION
OF PLASTIC HINGES IN SIMPLE
RIGID FRAMES

Submitted to
The Faculty of Rensselaer Polytechnic Institute
in partial fulfillment of the requirements for
the degree of
Master of Civil Engineering

June, 1951
Troy, New York

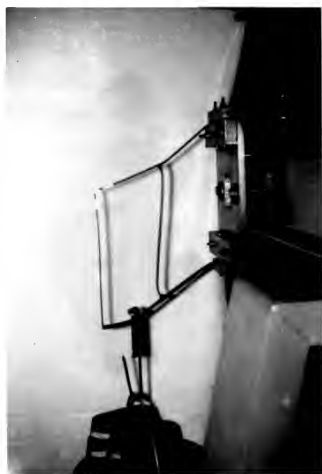
FIGURE 17

Theoretical Analysis of Two-Bay Single Story Rigid Frame:

We did not have sufficient time to construct and subject this particular frame to laboratory test. We have however undertaken the theoretical analysis of the frame. This analysis appears in Figure 17.
